Innovative Gullies
Remediation Project

Strathalbyn Station Gully Remediation Works Update

July 2019

Report prepared by Damon Telfer
Fruition Environmental Pty Ltd

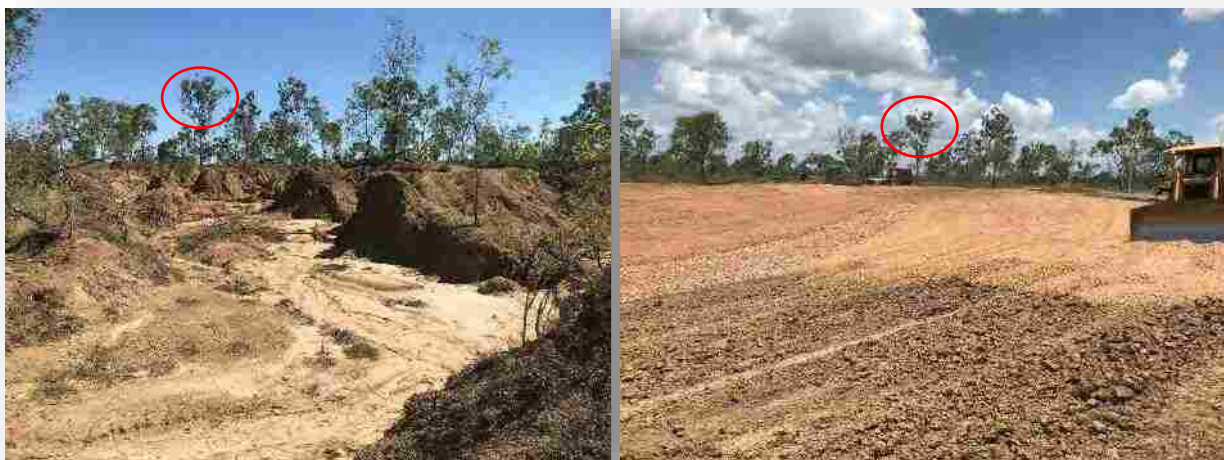
Plate 1 Before and after remediation works at the Treatment 1 site

Treatment 1 involved the use of earthworks machinery to reshape and regrade a 1.2ha alluvial gully site and then follow up treatments to stabilise the new landform (*Plate 1*). Follow-up treatments at this site included:

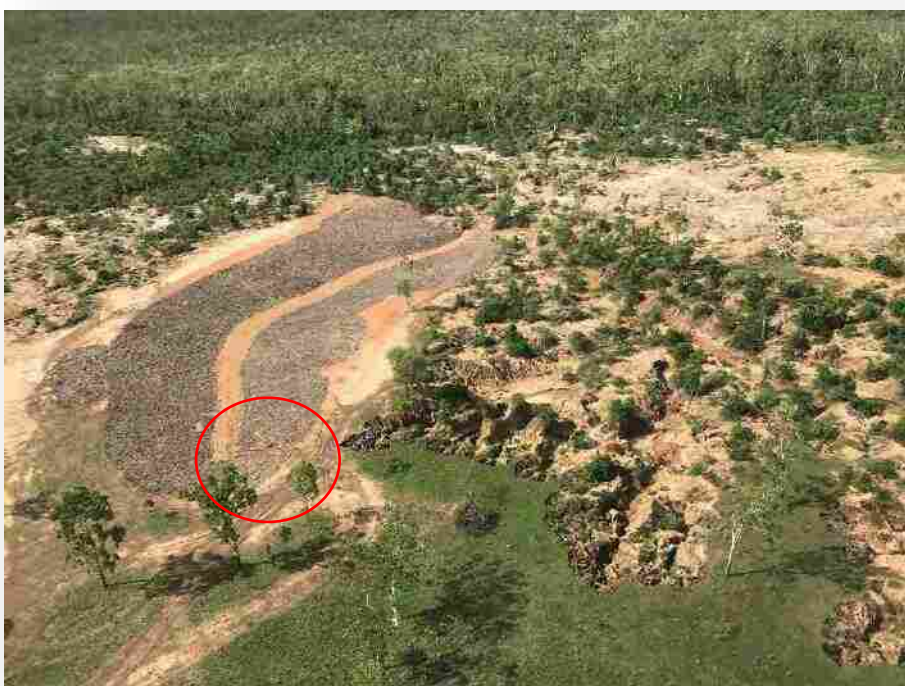
1. There has been an area of repeat rilling of the batter face in the south east corner of the remediated gully (see *Plate 2*), caused by overland flow during intense rain events. This area was repaired in July 2018 using the 50mm minus quarry materials, with two whoaboys installed on the remediation access track to dissipate flows to the area. Despite these actions the rilling reappeared again during the 2018-2019 wet season. The area was subsequently repaired in July 2019 using porous cobble checks down the batter face and bagasse bunding to reduce flow velocities above the batter. **Avoiding creating access tracks to the heads of gullies is an important lesson from this experience.**

Plate 2
Treatment 1 site in May 2018, at the end of the 2017-2018 wet season

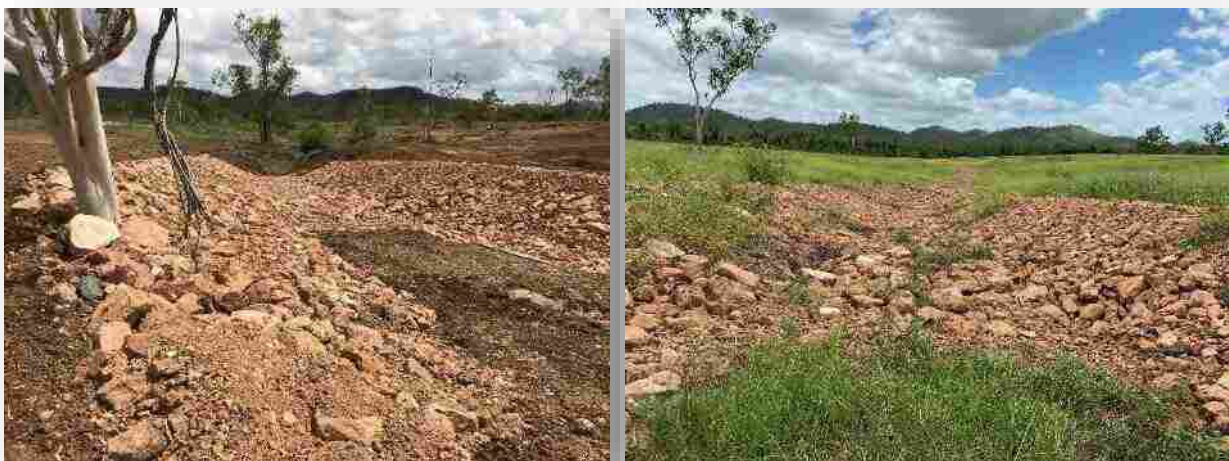
The diversion drain and chute have been stable over the two subsequent wet seasons since installation.

Plate 3 Treatment 5 rock chute installed in November 2017 prior to the Treatment 8 remediation in 2018 (left image), and same site in February 2019 post Treatment 8 and mid 2018-2019 wet season.

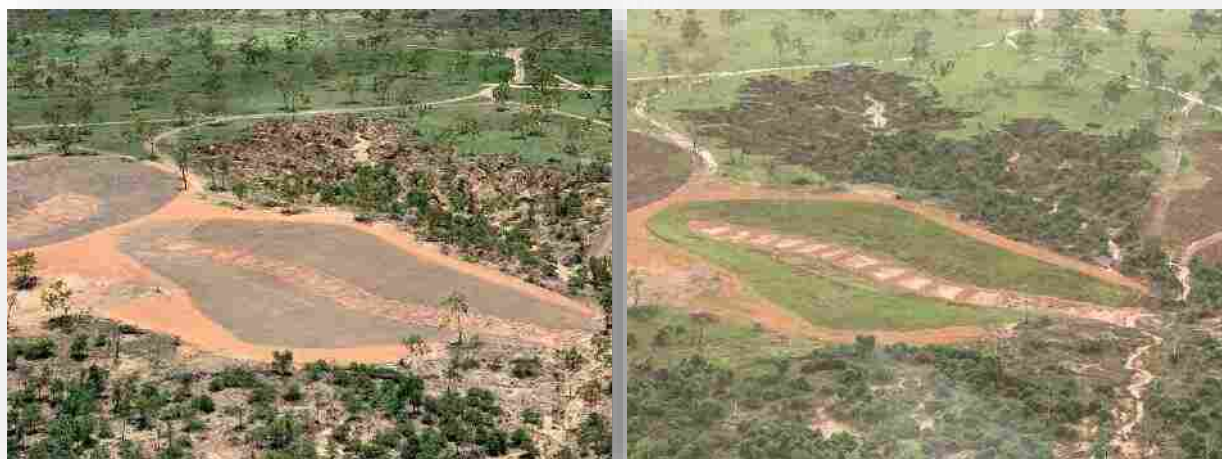
Plate 4 Treatment 2 in December 2018 post-completion (left) and in February 2019 mid 2018-2019 wet season, note the heavily incised control gully in the photo backgrounds.

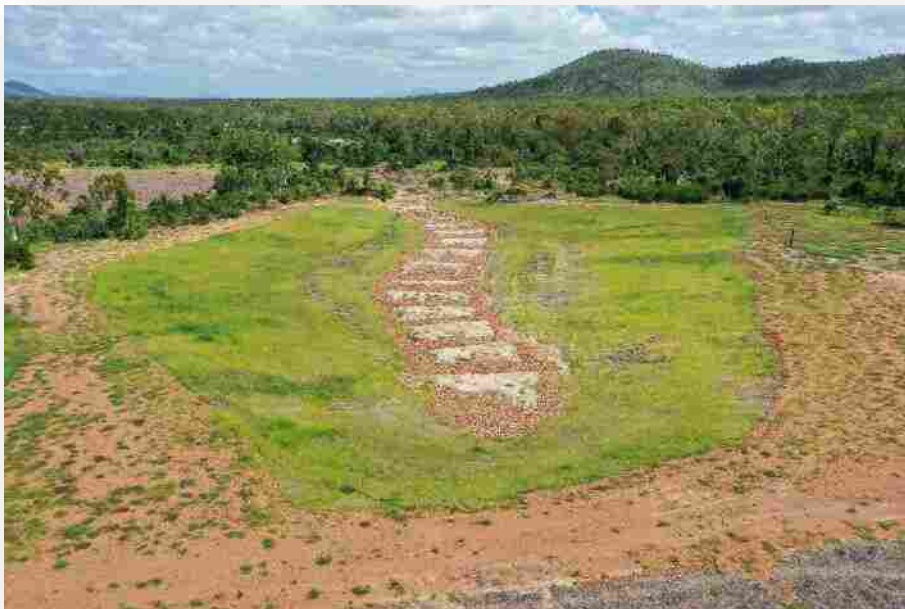
*Plate 5
Treatment 2 site in
February 2019, midway
through the 2018-2019 wet
season.*

1. Germination of direct seeded grasses was initially poor. This is thought to be due to the seed not being able to be effectively incorporated into the soil surface after placement of the coir mesh. The site was reseeded and was subsequently relatively successful. There is a clear contrast evident in grass cover above the gully however this is predominantly due to these areas not been seeded.
2. Rilling and some erosion at the interface of the gravel capped upslope areas and the topsoiled and coir netted batters was evident wherever the slope concentrated flows towards the batter. This is despite this area being graded flat upon completion of the coir placement. **It would seem judicious to attempt to try to slow flows at this interface using porous materials such as hay or debris or bagasse placed on the contour.**

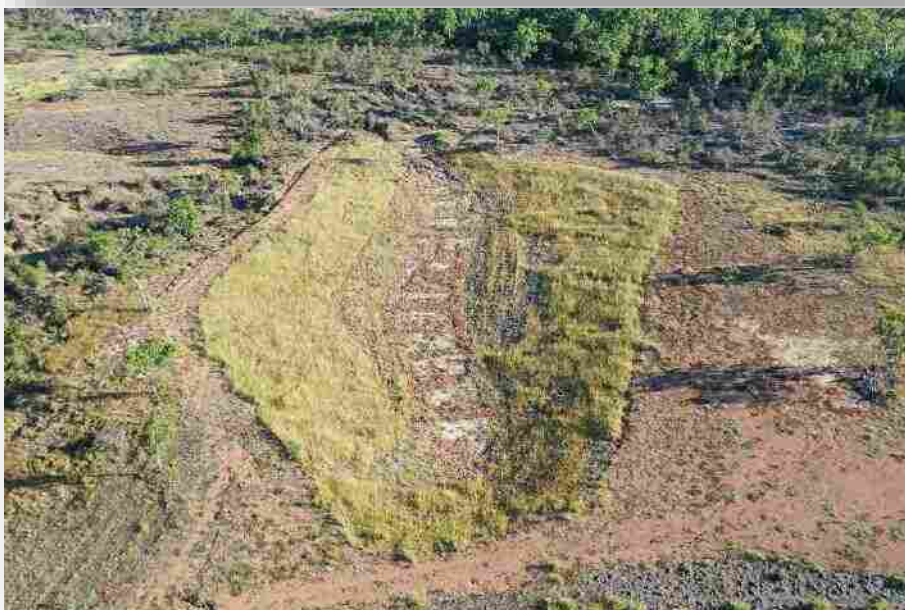
*Plate 6
Treatment 2 site in July
2019.*

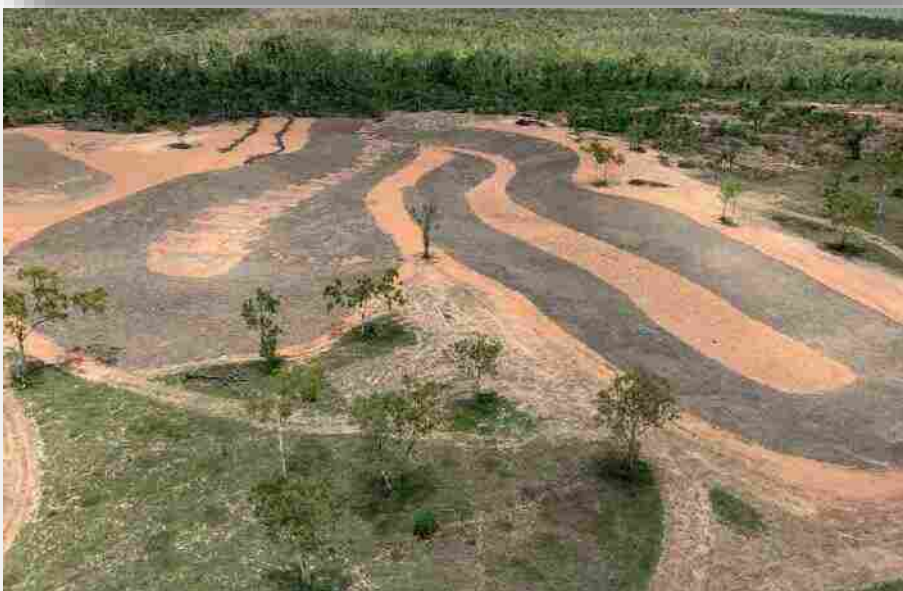
- Treatment 3 had ?? porous rock check dams constructed along the length of the gully bed, Treatment 4 had a graded rock bed including 50-150mm quarry materials for the upper two thirds of the bed and larger ~ 250mm materials used in the lower third (see *Plate 8*);

Plate 8
Treatment areas 3 and 4 post remediation in December 2018.

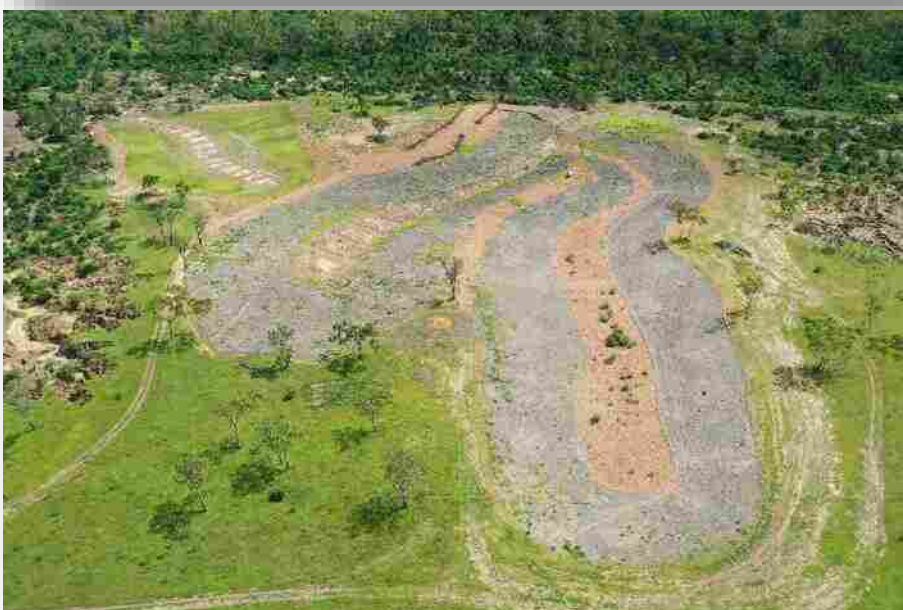
- Both treatment areas were hand seeding at two sperate intervals at approximately 20kg per hectare using exotic perennial grass species including Tolga Rhodes and Sabi grass (40kg per hectare total application). Seed germination and establishment appeared more successful on Treatment 3 when compared to Treatment 4 (see *Plate 9*)

Plate 9
Treatment areas 3 and 4 midway through the 2018-2019 wet season, February 2019.

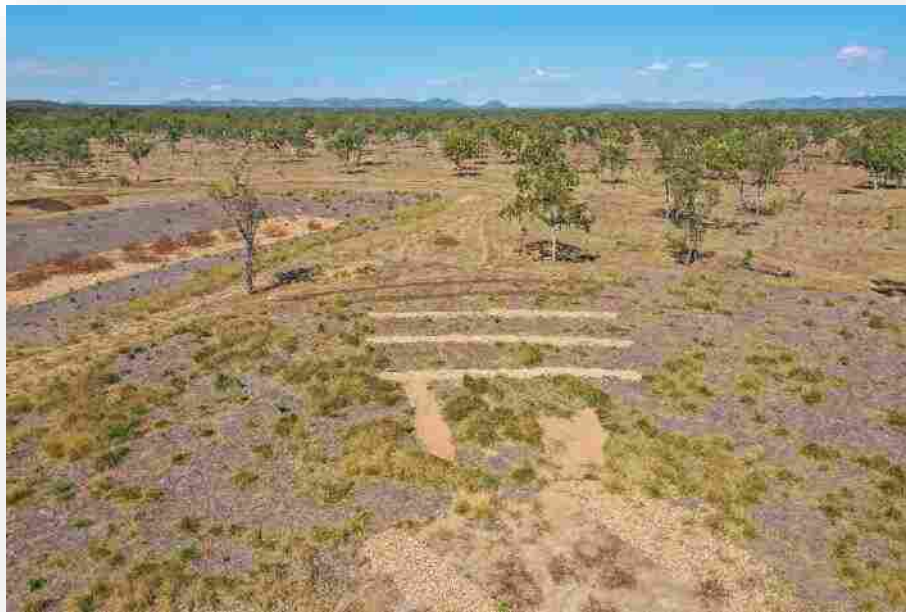
1. Of note, rill erosion in the corners of the upstream “cul-de-sac” area of the post remediation gully form, similar to that which occurred in Treatment 1, was evident on both gullies and particularly on the east side batter slope of Treatment 3. It is clear that, during periods of

*Plate 12
Cobble (50-150mm quarry rock) and bagasse checks installed at the location of rilling on the batter face caused by concentration of overland flow during intense rainfall events.*

heavy rainfall, overland flow over the upslope areas and down the batters still creates an erosion risk. Once rilling erodes through the batter capping and then through the gypsum treated top of the sub-surface, the reinitiation of erosion of the underlying dispersible soils is likely. **The use of porous check structures in the corners of the gullies at locations where surface flow is likely to be concentrated is recommended as a preventative measure (see Plate 12).**

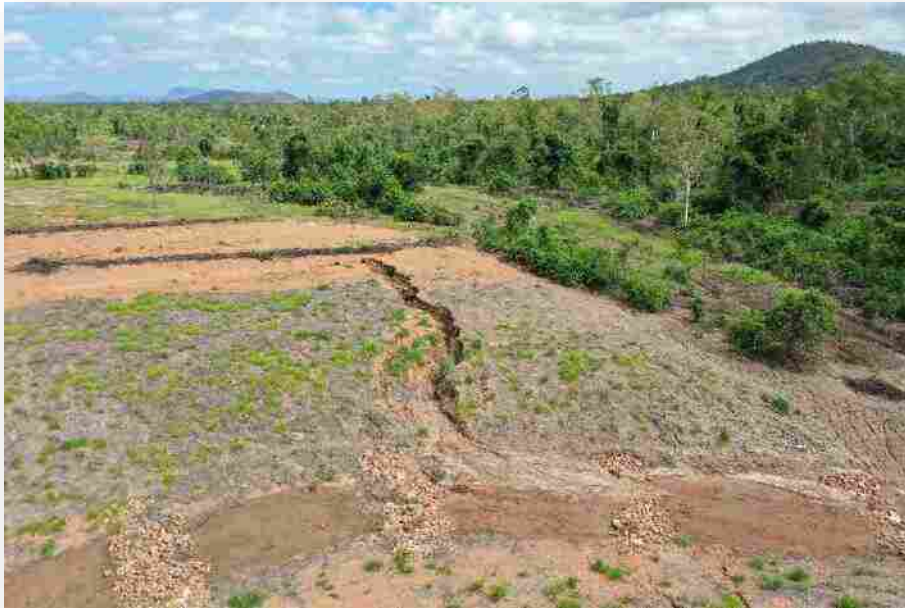
2. At the downstream end of Treatment 3, a slight depression in the upslope (above batter) area has created a drainage basin which has concentrated flow down the adjacent batter. The depression eventuated from an error in the design quantities that left too little fill to create an even free draining area at this location. The issue was identified in November 2018 and debris was placed along the contour to reduce the potential for concentrated overland flows. In December 2018 diversion bunds were installed to spread flows however these efforts were undermined by an intense rainfall event which dumped 65mm of rain on the site over the site in a 50 minute period, 10 minutes after construction was completed. The result was that the bunds failed and a large incision was initiated down the batter face (see Plate 13). The erosion liberated approximately 80 tonnes of sediment into the bed. Repairs were undertaken in June 2019 including regrading the eroded area, constructing a rock lined batter chute, reorientating the diversions to direct flow down the chute, and reinstating the debris bunds to slow flows (Plate 14). **The main lessons learnt from this experience are to ensure that designs and any subsequent earthworks do not leave drainage depressions that concentrate event flows down the batters as the capping materials are not sufficient to prevent significant erosion via these processes.**

*Plate 13
Erosion on the batter face
caused by failure of
diversion bunds intended to
disperse concentrated flow
caused by a small drainage
depression after
earthworks.*

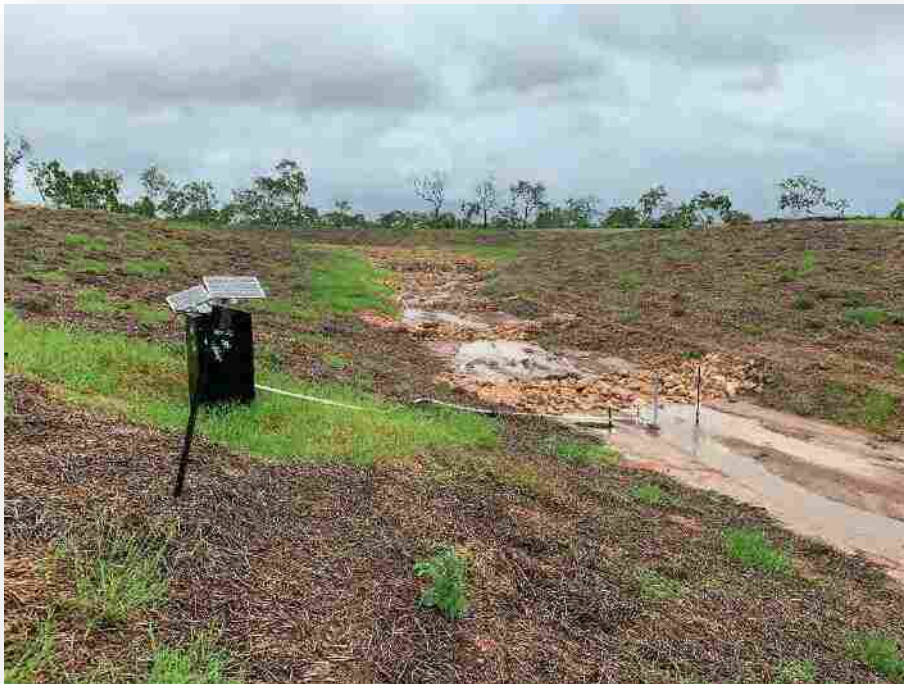
3. The porous rock check dams installed in Treatment 3 have proved effective at trapping sediment within the bed of the gully (including fine silts and clays; see *Plates 15 and 16*). Some reorganisation of bed sediments between the check dams can be expected. The design used which is to have a low but wide rock check (approximately 200mm high but 2.4m long and full channel width) appears to reduce scour at the downstream extent of the check provided the appropriate spacing is used to allow back-flooding of upstream checks during higher flow events.

*Plate 15
Porous check dams
installed in the bed of
Treatment 3.*

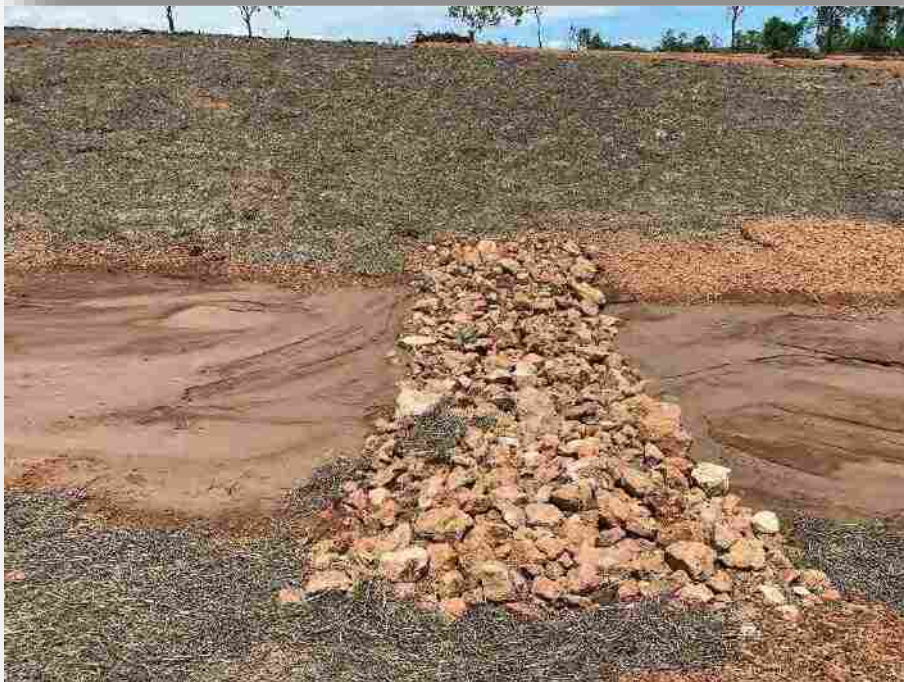
*Plate 16
Approximately 200mm
depth of sediment
deposition behind porous
check dams in Treatment 3,
flow from photo left to
right*

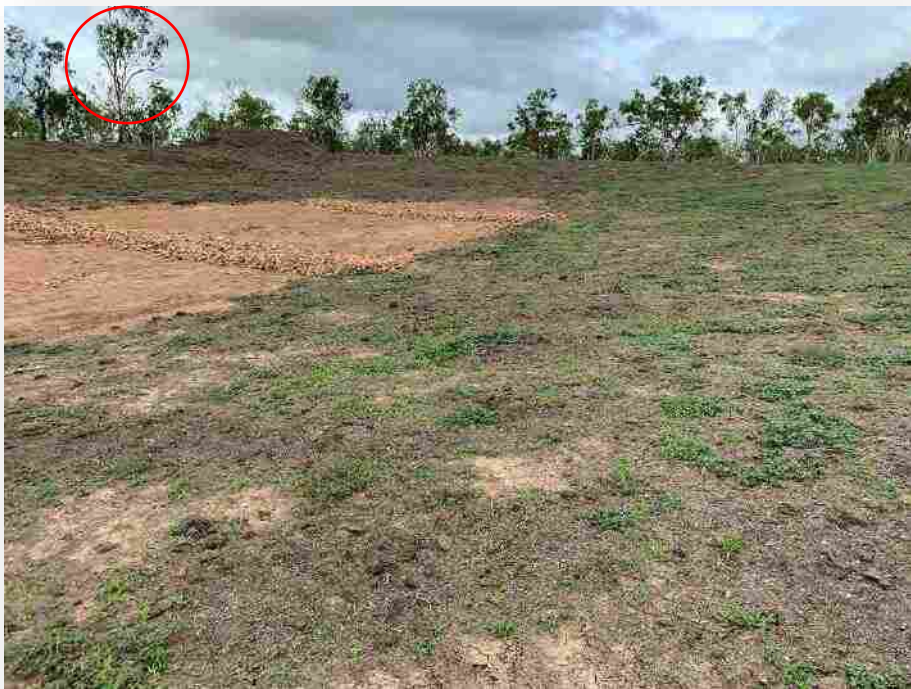
1. The seed germination and establishment rate far exceeded any of the other treatments used to date (see *Plate 19* and *20* overleaf).
2. No rill erosion from overland flow occurred on this site predominantly because overland flows were diverted to an adjacent catchment under an adjoining Australian Government funded Reef Trust program (remediation of an adjacent photo is visible in the top right corner of *Plate 18*)

Plate 19
Early establishment of sown exotic grasses at Treatment 7.

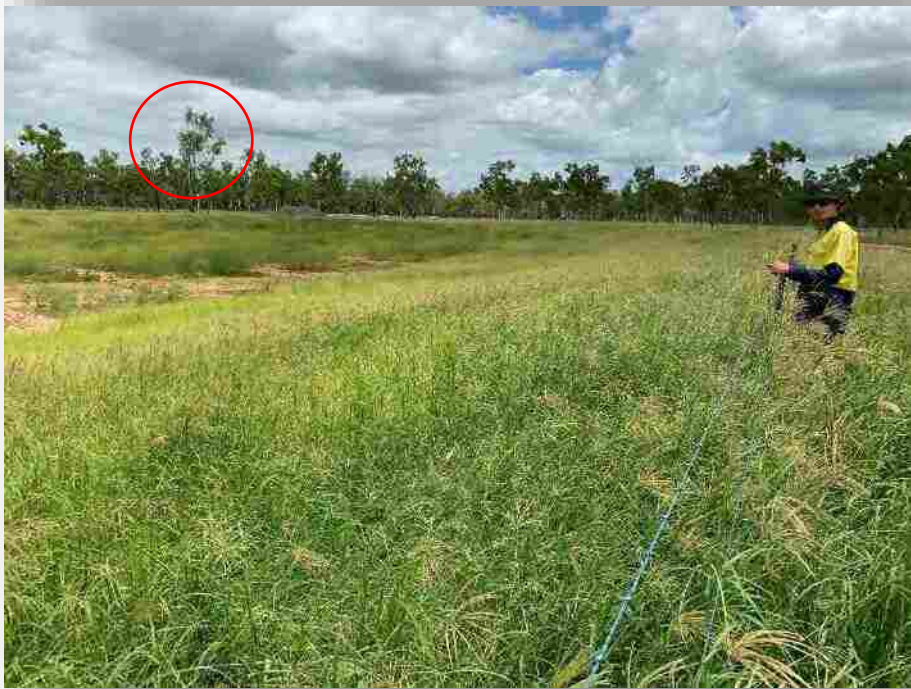
Plate 20
Grass establishment on the Treatment 7 batters midway through the 2018-2019 wet season in late February 2019.

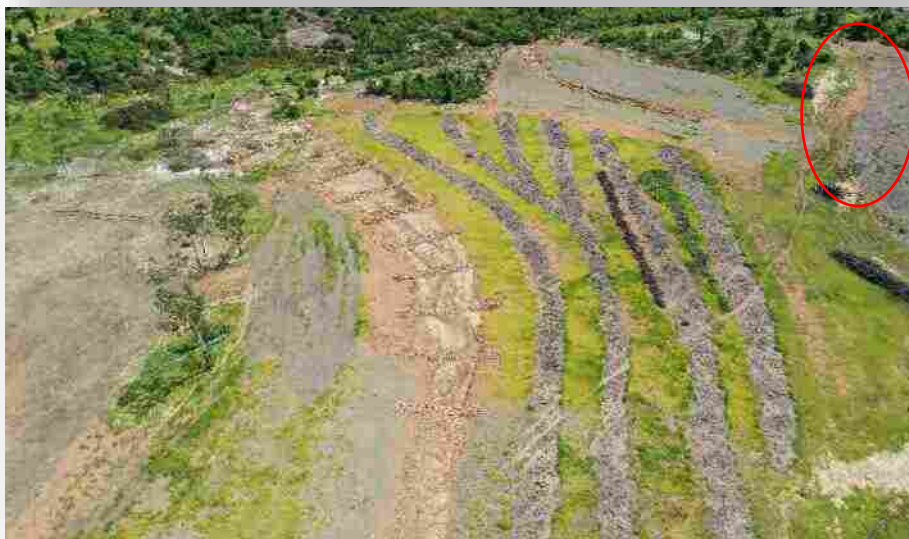
Plate 22
A long low slope batter on the downstream eastern extent of Treatment 8 as a result of a plan redesign necessitated some innovative approaches to slope stabilisation.

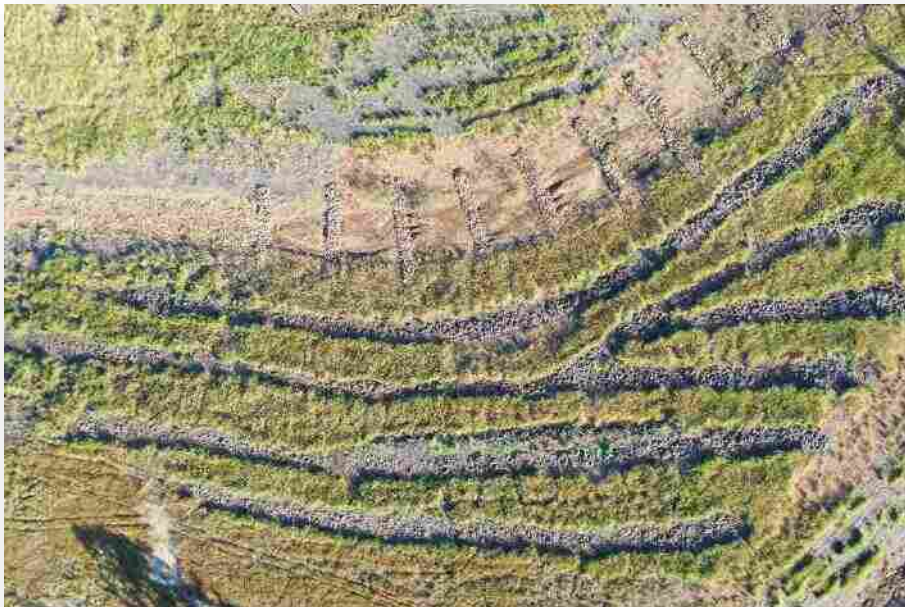
1. At the downstream eastern extent of Treatment 8, the long batter slope was stabilised using a mix of wide and widely spaced Rhodes Grass mulch bunds on the contour interspersed with debris bunds (salvaged from the pre-earthworks grubbing of the gully). This area was then heavily seeded with exotic perennial grass seed (*Plate 23*)

Plate 23
Hay and debris bunds inter-sown with exotic grass seed on the downstream eastern batter of Treatment 8 proved very effective for stabilising long low slope batters.

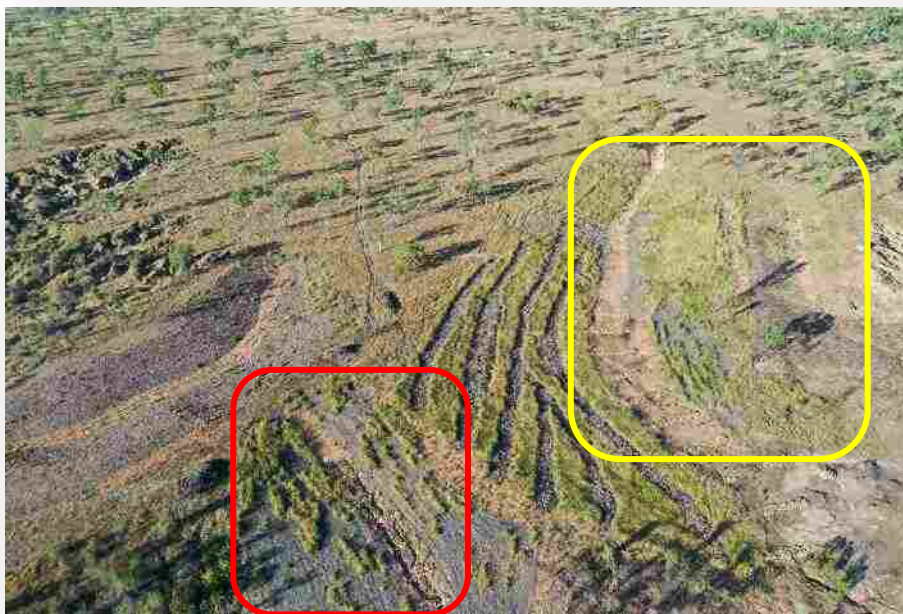
2. Across the majority of the remaining Treatment 8 batters, bagasse was spread at a depth of 50-100mm to provide a cover mulch over the gravel capping with the intent of holding sufficient moisture to improve revegetation success. Bagasse was spread using two methods, firstly using a semi-trailer mounted mulch blower which proved slow and expensive but also shredded the bagasse into fine particles which appeared to be less resistant to flow (appearing to wash down the batters during intense rainfall). The second approach was to spread the bagasse using a small side-tipper and grader which was quicker and produced a better effect in terms of material thickness and resilience to rain and run-off. *Plate 24* provides some indication of the areas treated with bagasse using the blower (area indicated by the yellow rectangle) as opposed to the side-tipper and grader (red rectangle).

Plate 24
Areas of bagasse spreading on the Treatment 8 and 8b batters, yellow rectangle indicates areas where a mulch blower was utilised, red rectangle is where a side-tipper and grader were used.

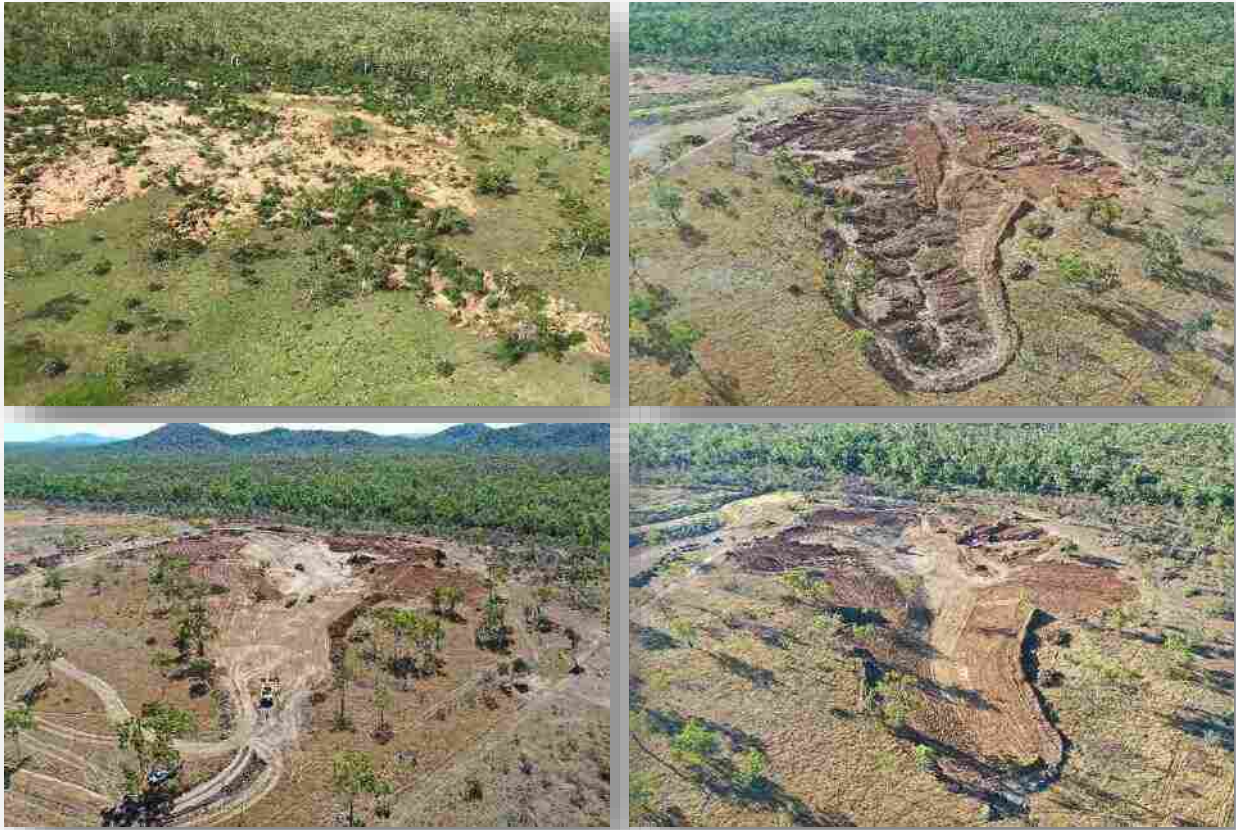
Plate 25

Phases in the remediation of the Treatment 6 gully (clockwise from upper left): the gully prior to remediation works in early 2019; bulk earthworks commenced including foundation preparation to remove tunnel erosion and topsoil stripping; bulk earthworks nearing completion with batter grades established; rock chute being installed with associated diversion bunds.
