Innovative Gully Remediation Project

FINAL PROJECT SYNTHESIS REPORT

Report prepared for Greening Australia
Ltd and Queensland Department of
Environment and Science

Report prepared by Damon Telfer
Fruition Environmental Pty Ltd

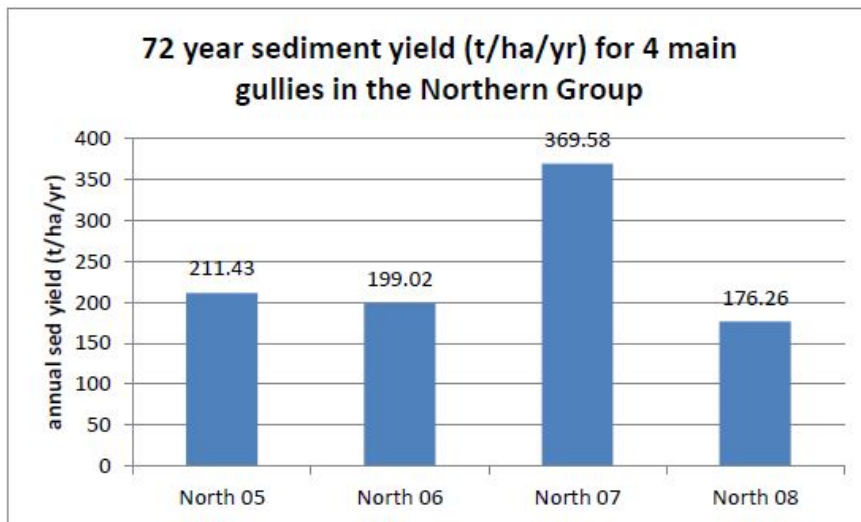
This showed that the Northern Gully complex, when compared to sediment yields derived from multitemporal LiDAR analyses over other gullies in the project area, contained a cluster of the highest fine sediment yielding gullies within the project area.

Figure 4 Initial estimates of per unit area sediment yields from the Northern gully complex on Strathalbyn Station between 1945-2016 (Source: Brooks et al, 2017)

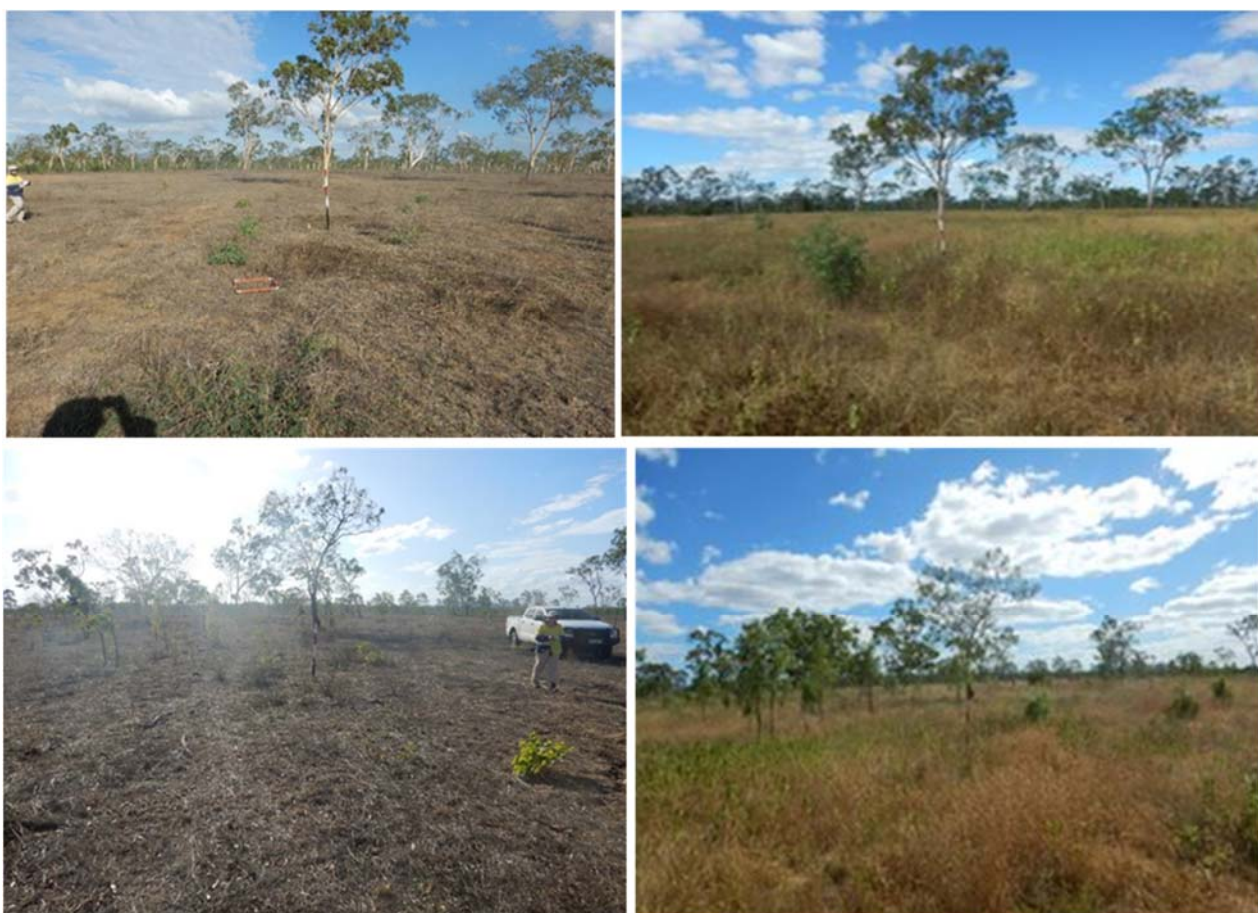
Land Condition Assessments conducted in gully catchments showed improved land condition ratings after implementation of gully remediation. Variables identified by Chilcott et al 2003 including dry matter (DM) yield, tree cover, palatable plant species, tree basal density, sapling diameter, tree count etc. were used to generate an overall land condition rating. Treatment sites three and four were both rated as “poor condition” prior to gully remediation, but received “good condition” and “excellent condition” ratings respectively, after gully remediation ((Plate 4). The locations of the LCA monitoring points for Treatment 3 and Treatment 4 are shown in Figure 15. The LCA’s also provide a visual representation of the changes in landscape over time, such as the increase in ground cover and establishment of mid-storey vegetation. LCA’s were developed for use by landholders so these results are indicative of grazing potential and are useful for communication with landholders and graziers.

Plate 4 LCA monitoring points in gully catchment of treatment three (above) and four (below) before gully remediation in 2018 (left) and after gully remediation in 2020 (right). Source: Greening Australia, 2021.

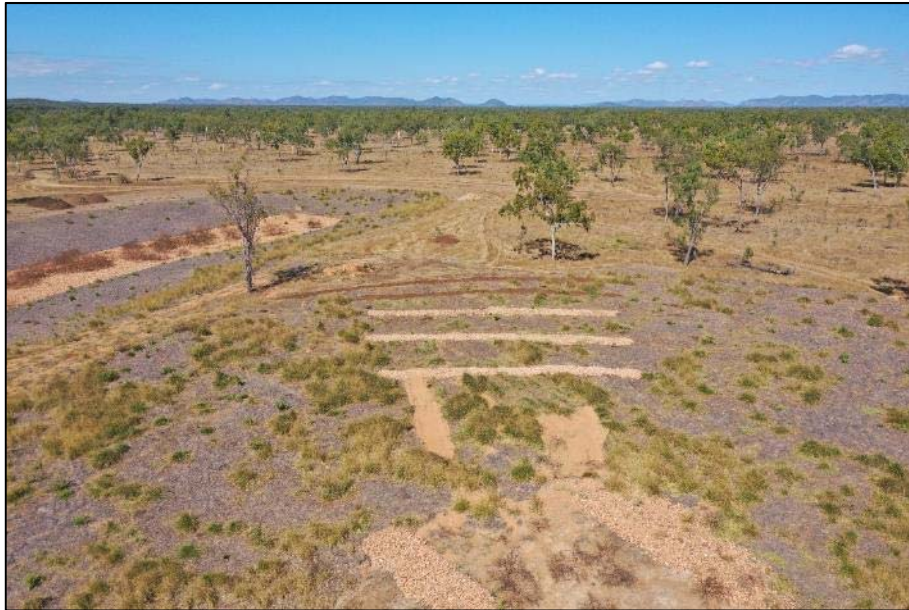
Plate 5
Cobble (50-150mm quarry rock) and bagasse checks installed at the location of rilling on the batter face caused by concentration of flow during intense rainfall events.

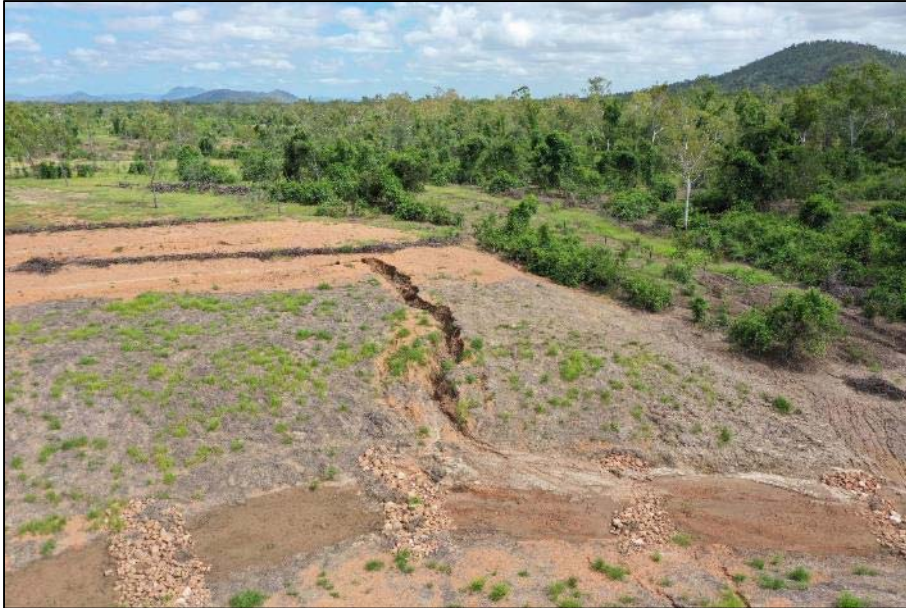
*Plate 6
Erosion on the batter face caused by failure of diversion bunds intended to disperse concentrated flow caused by a small drainage depression after earthworks.*

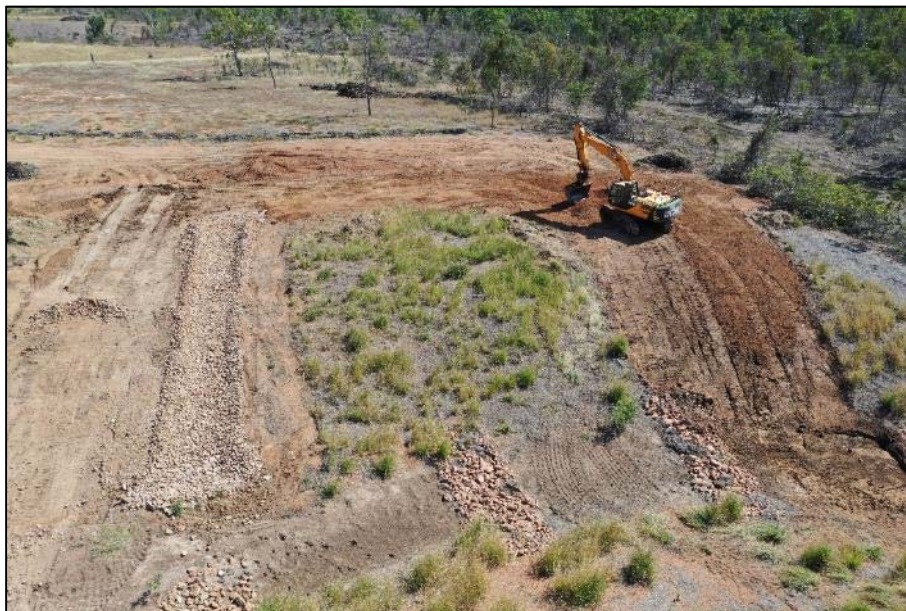
*Plate 7
Repairs of the above site underway involving the regarding of the eroded area and construction of a batter chute to take flows (diversion bunds to the throat of the batter chute not yet installed at the time of photo).*

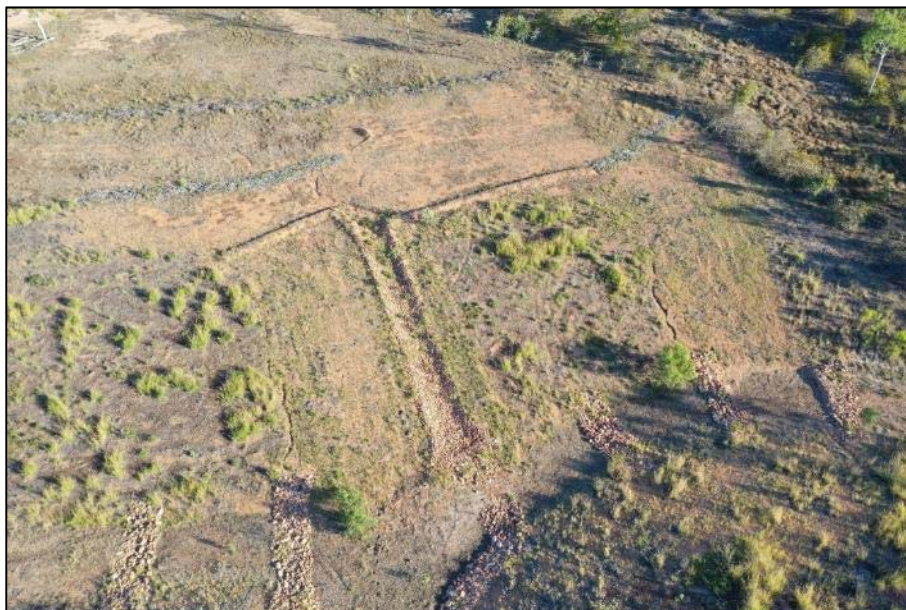
*Plate 8
Repairs upon completion in August 2019*

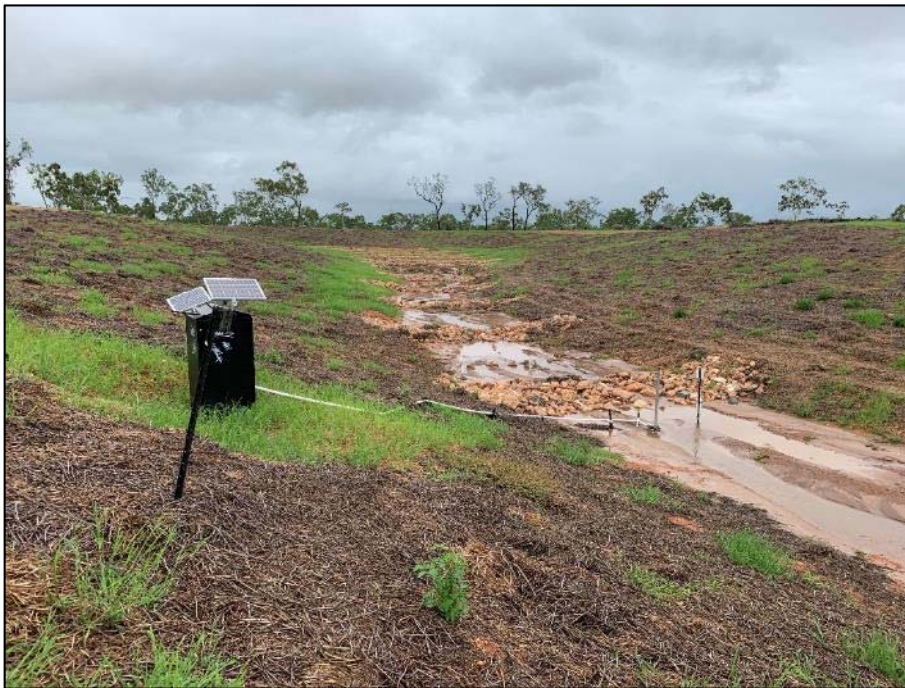
*Plate 9
Porous check dams
installed in the bed of
Treatment 3.*

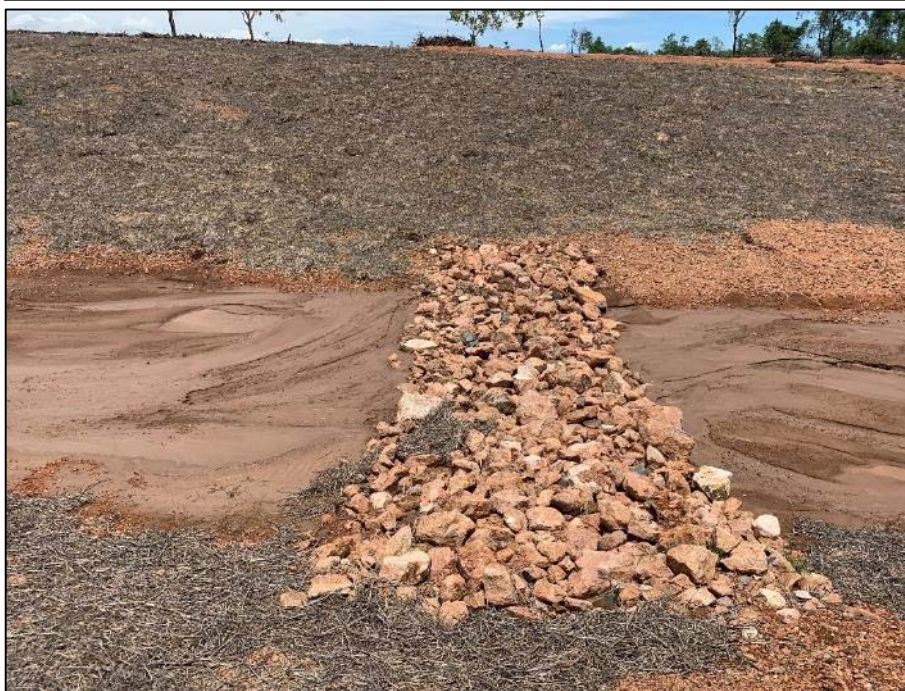
*Plate 10
Approximately 200mm
depth of sediment
deposition behind porous
check dams in Treatment 3,
creating the typical stepped
profile (flow from photo left
to right)*

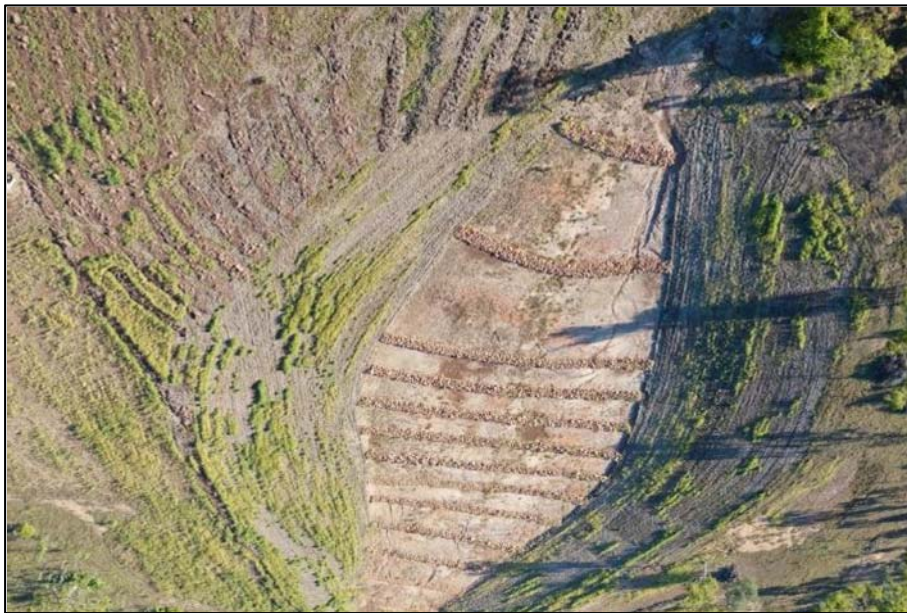
Plate 11
Outflanking of check dams
at the downstream end of
Treatment 6

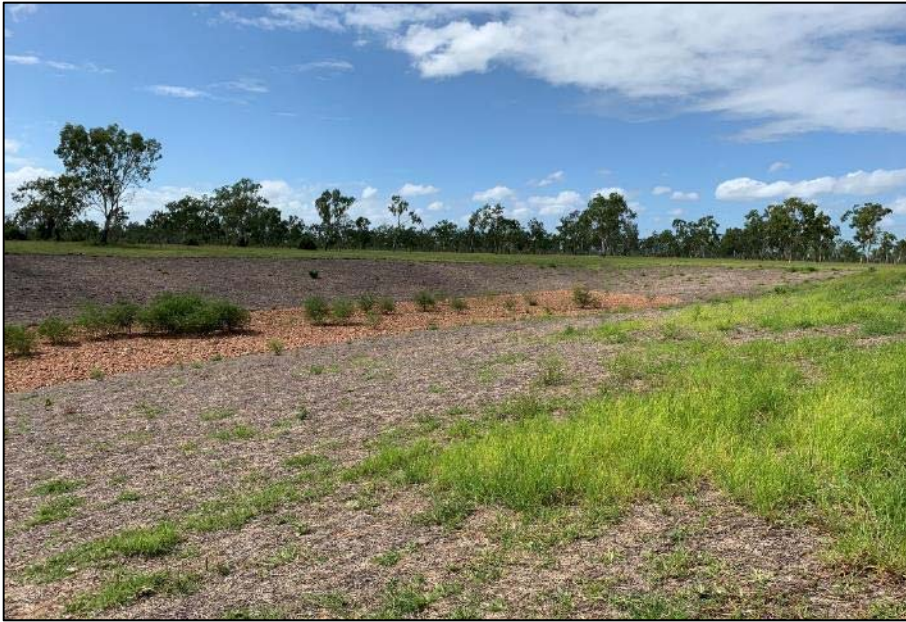
Plate 12
Graded rock bed in
Treatment 4, showing early
stages of natural
colonisation of vegetation

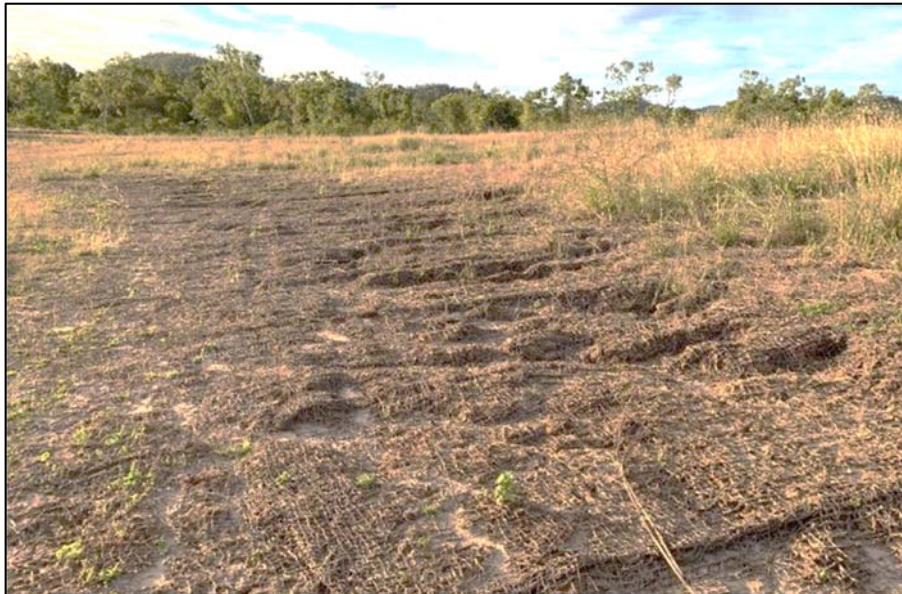
Plate 13
Rill erosion underneath the
jute mesh covers installed
on the Treatment 2 batters

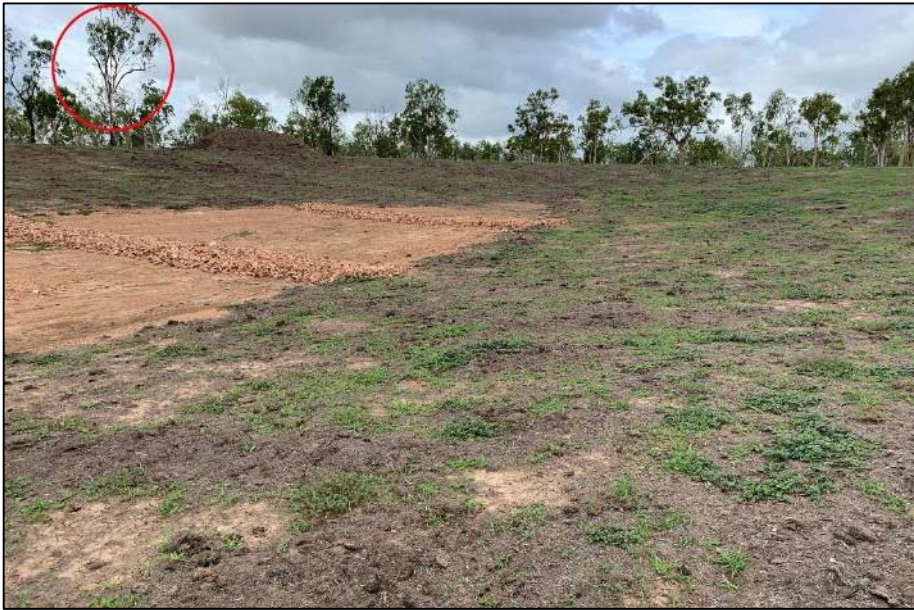
Plate 14
Treatment 7 three months
after construction in
December 2018

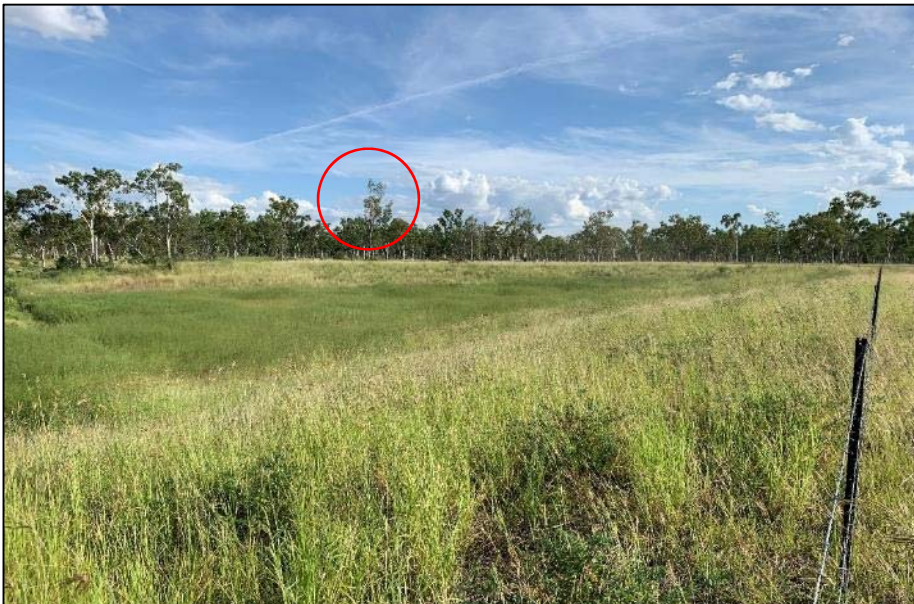
Plate 15
Treatment 7 in April 2020,
18 months post-
construction

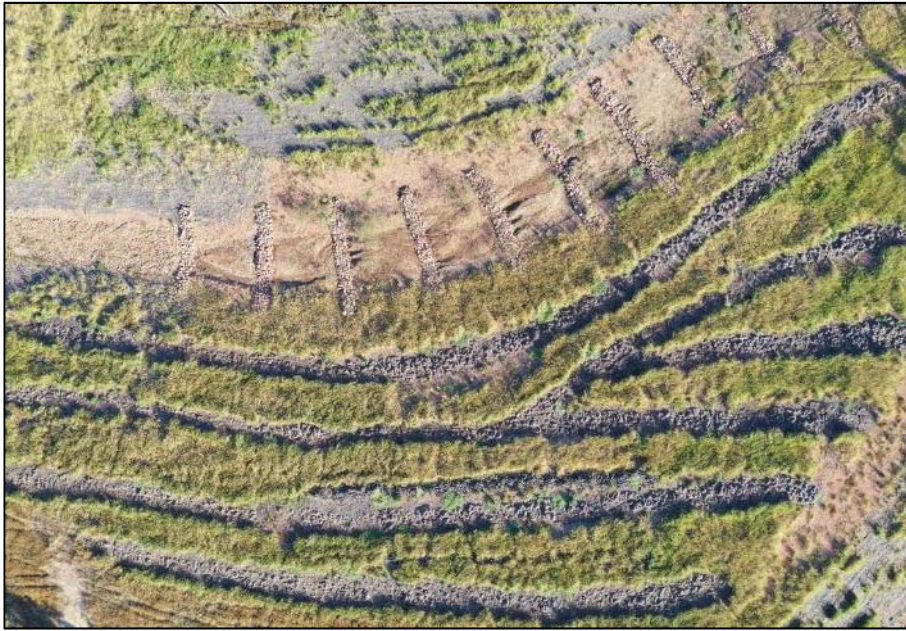
*Plate 16
Debris and hay bunds
installed on the contour in
Treatment 8*

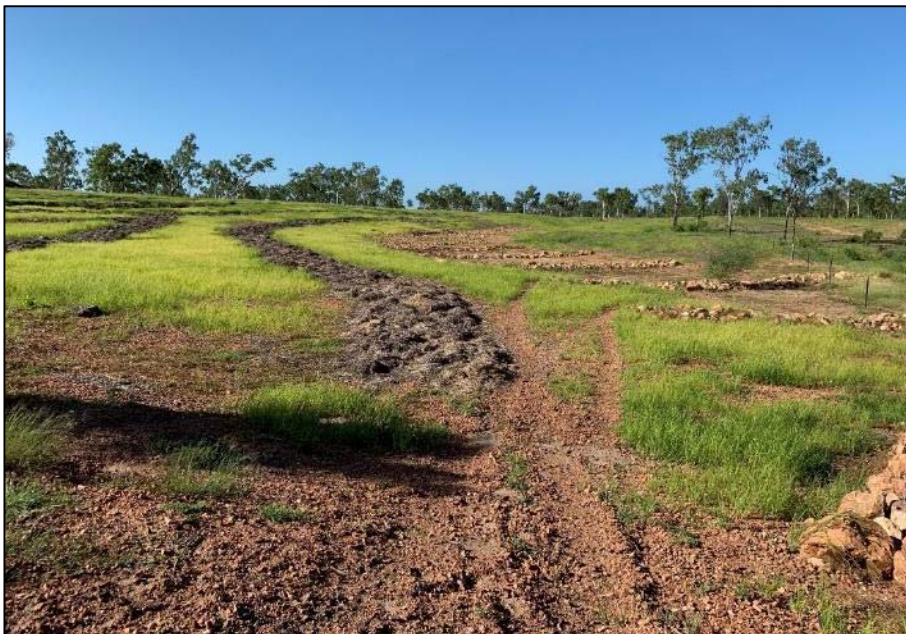
*Plate 17
Grass growth in the seeded
area between hay bunds*

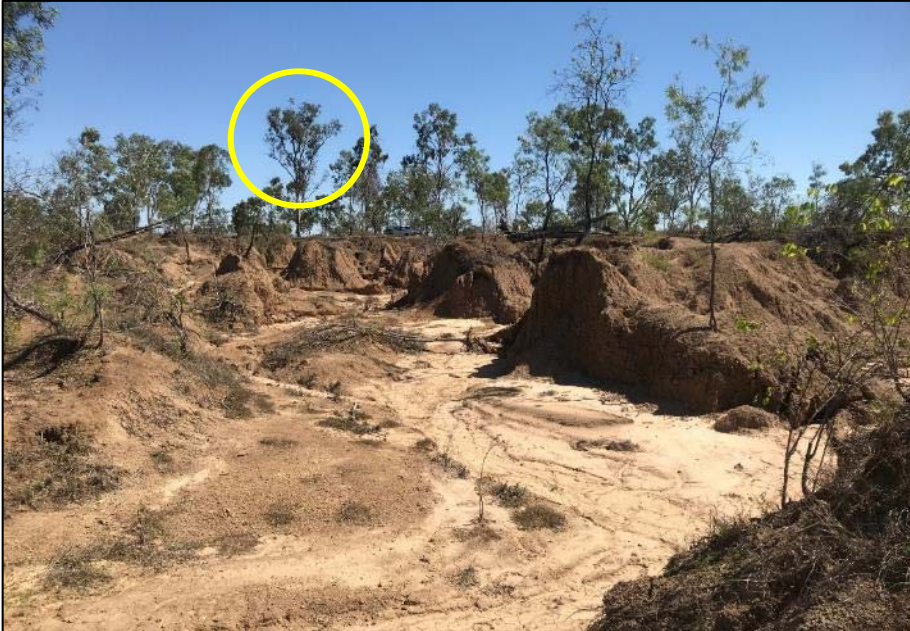
Plate 18
Treatment 1 in August 2017
prior to treatment

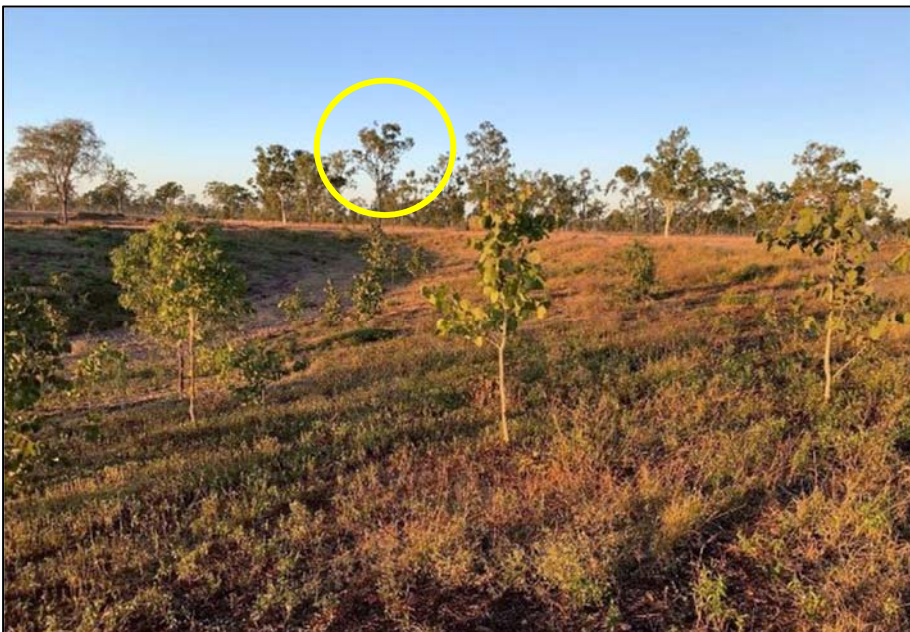
Interestingly, provided the substrate is stable, older treatment sites tended to exhibit significant recruitment of additional exotic and native species (see *Plates 18 and 19*). It is hypothesised therefore that the initial vegetation establishment goal should be to ensure rapid cover of the ground surface with perennial species (generally grasses but legumes and forbs are also useful) without too much concern for initial diversity.

Plate 19
Treatment 1 in August 2020
showing recruitment of
native trees and a diversity
of shrubs, forbs and some
native grasses. Only exotic
Sabi grass and Rhodes
grass was sown at this site.

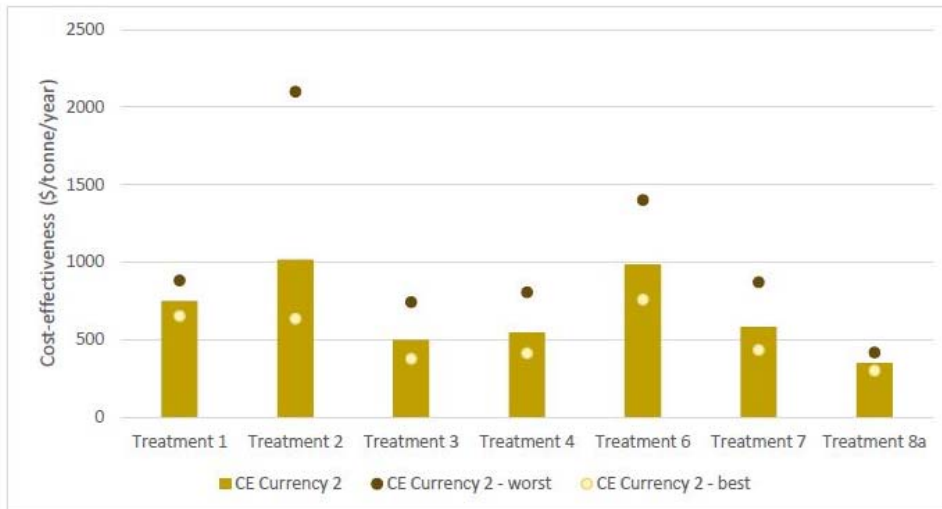
Figure 23 The end of system (GBR Lagoon) cost-effectiveness for all treatments calculated using the CE₂ methodology, analogous to the current Reef Trust method for calculating cost-effectiveness (Source: Brooks et al., 2020).

The data reveals some interesting anomalies. For instance, both Treatment 2 and 6 were trialed as lower-cost treatment approaches which, after earthworks, utilised only gypsum treated soils for capping and lower cost mulch and seed applications on the surface. As could be expected for lower cost trials, these two treatments have been shown in this analysis to be the two least effective treatments (between 78-84% effective). Paradoxically though, T2 and T6 are also the two most expensive trials on both the CE₁ and CE₂ cost-effectiveness measures. The explanation for this result is found in the particular circumstances of each gully.
