Innovative Gullies
Remediation Project

Strathalbyn Station Gully Remediation Works Update

July 2019

Report prepared by Damon Telfer
Fruition Environmental Pty Ltd

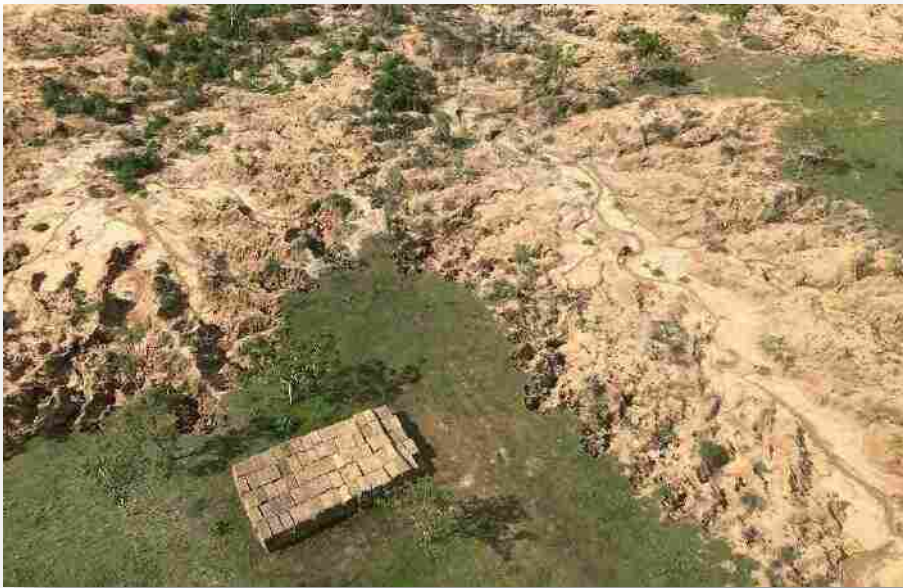
Treatments 3 and 4 involved the regrading of an entire gully complex which historically had exported in excess of 2000 tonnes of fine sediment to the GBR lagoon per year over a 70 year period. The earthworks involved significant foundation preparation of heavily tunnel eroded areas (see *Plate 7*) which caused a number of practical issues in terms of site management, earthworks process and project/contract management. Foundation preparation on this scale requires substantial double handling of excavated materials as the tunnelled area are boxed out, the material conditioned using water trucks and then compacted back into the reformed shape in 300mm layers using a dozer, excavator and padfoot roller. The area of the treated gully was expanded to include some additional areas below the design footprint which were also eroded allowing the entire area of alluvial gullying to be treated. The final area of treated gully was approximately 4.62 hectares (*Figure 4*).

Plate 7
The pre-remediation state of treatment areas 3 (left) and 4 (right) in February 2018. The hay stack contains 415 450kg Rhodes grass hay bales used in the 2018 remediation program.

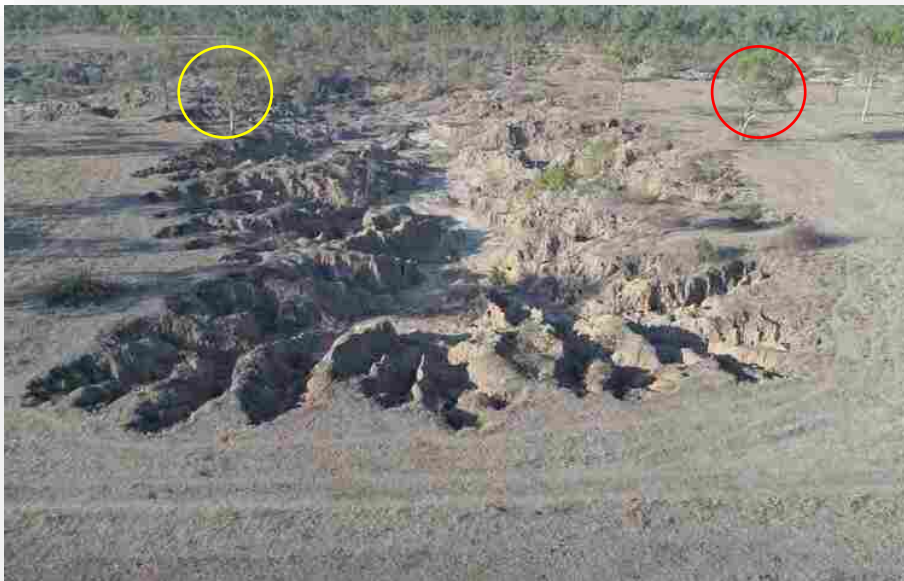
Plate 10
The pre-remediation state of treatment areas 3 (left) and 4 (right) in February 2018. The hay stack contains 415 450kg Rhodes grass hay bales used in the 2018 remediation program.

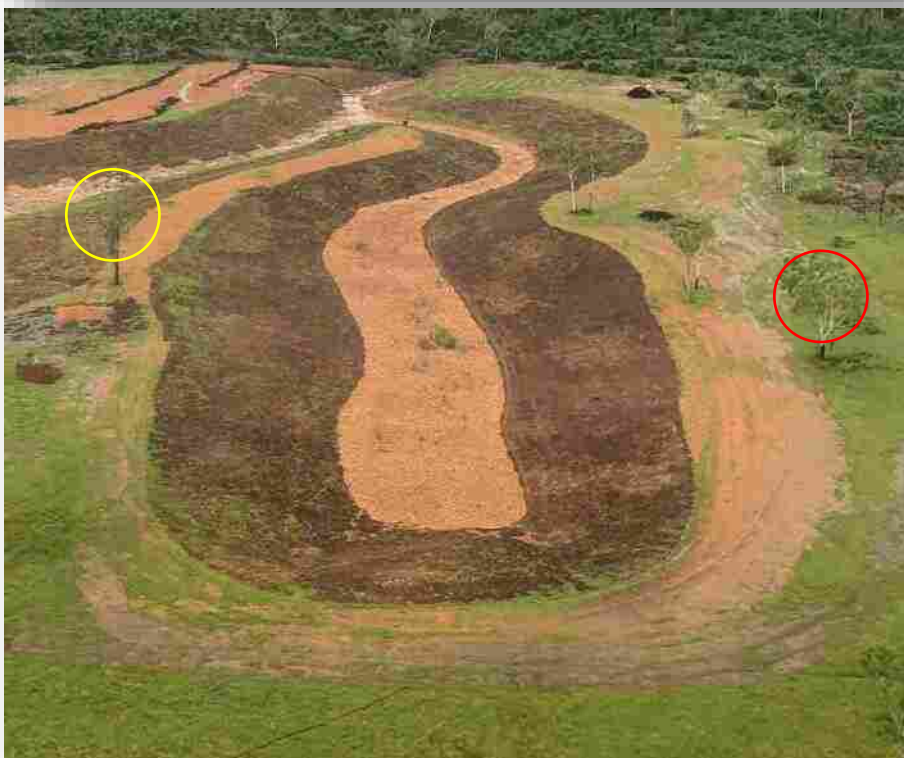
Plate 11
Treatment 2 site in February 2019, midway through the 2018-2019 wet season.

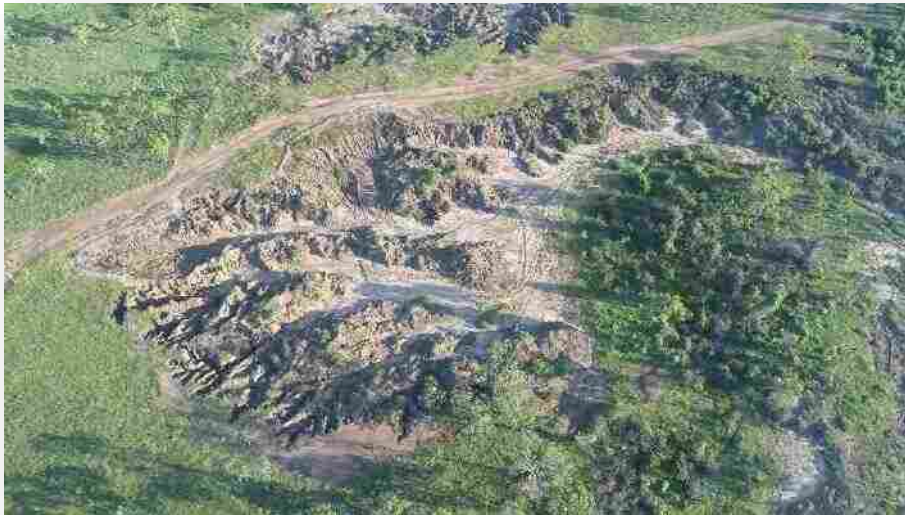
Plate 17
Treatment are 7 prior to
remediation works in early
2018

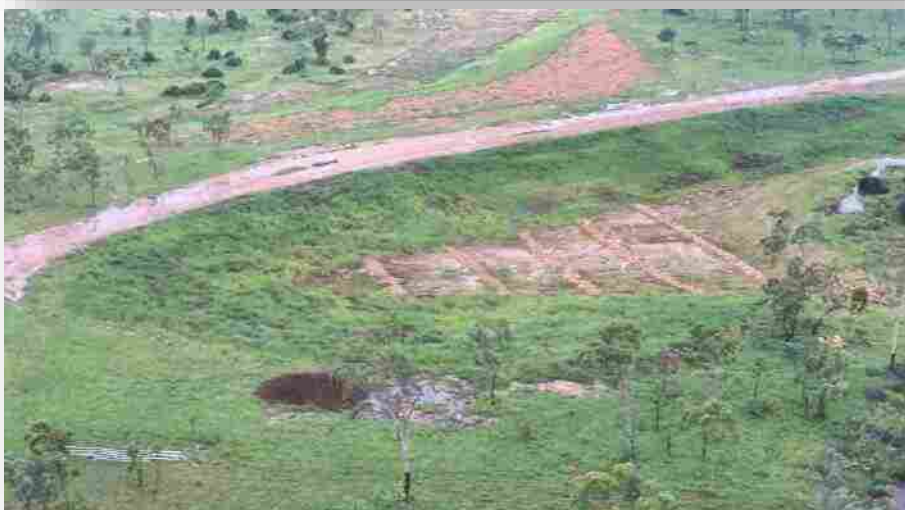
Plate 18
Treatment 7 post
treatment in February
2019.

1. The seed germination and establishment rate far exceeded any of the other treatments used to date (see *Plate 19* and *20* overleaf).
2. No rill erosion from overland flow occurred on this site predominantly because overland flows were diverted to an adjacent catchment under an adjoining Australian Government funded Reef Trust program (remediation of an adjacent photo is visible in the top right corner of *Plate 18*)

- Careful removal of all tunnel eroded areas, compaction at optimal moisture content, and regrading to a batter slope not exceeding 1V:5H;
- the application and incorporation to 0.15m depth of gypsum at 18t/ha over the batters, bed and disturbed upslope areas;

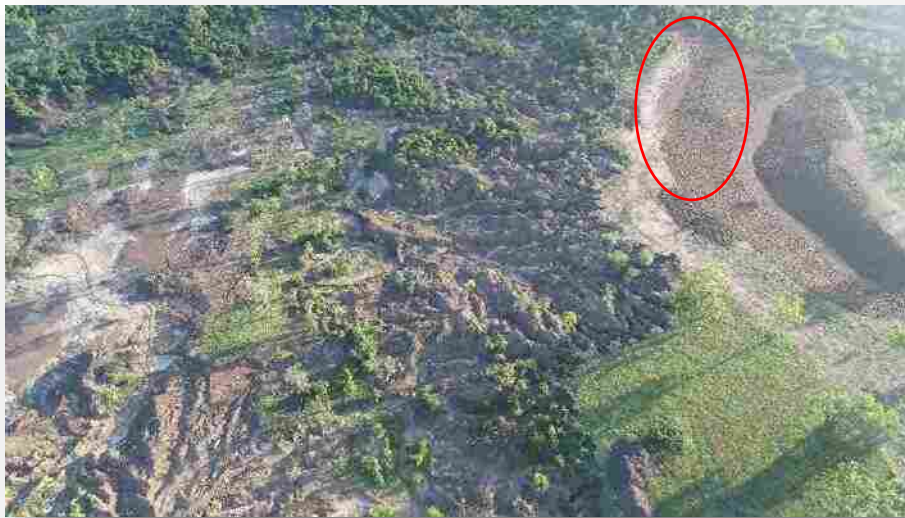
Treatment 8 targeted a large complex gully system downstream of the Treatment 5 rock chute. The gully complex had multiple fans expanding from a central drainage line. The initial design created three remediated gully basins however problems with design quantities forced an on-site redesign. The final “as-constructed” design created a large basin with a significant batter slope at the downstream eastern extent (approximately 90m; see *Plate 21* and *22* below) with a small but steep secondary remediated gully to the north east (known as Treatment 8b, see upper middle of *Plate 22*).

Plate 21
Complex multiple gully fans were a feature of the Treatment 8 site.
